**Flood Control Project Maintenance
Levee Inspections**

Fall 2008 Levee Maintenance Deficiency Summary Report

Reclamation District No. 1601

Waterway							Bank	Unit Miles	Inspection Date	Inspector	
Unit No. 01 Threemile Slough							Left	2.50	09/22/2008	Richard Willoughby	
LMR Line	Levee Mile		Category	Item	* Location	** Rating	Action/Comment	GPS Latitude/Longitude		Photo	Issue
	Start	End						Start	End		
1	0.05	0.05	Earthen Levee	Repair Gates	CR	A		38.121562 ° -121.682710 °	38.121562 ° -121.682710 °	Y	1
2	0.11	0.11	Interior Drainage & Piping Systems	Metal Pipes	LS	A		38.120709 ° -121.682800 °	38.120709 ° -121.682800 °	Y	2

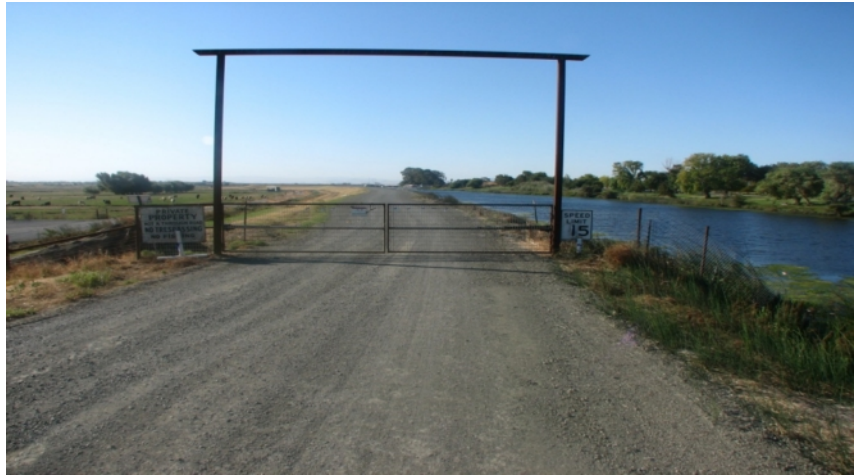
Levee Mile Report Line	1
Start Levee Mile	0.05
End Levee Mile	0.05
Location	
Category	Earthen Levee
Item	Repair Gates
Looking downstream at new gate across levee crown.

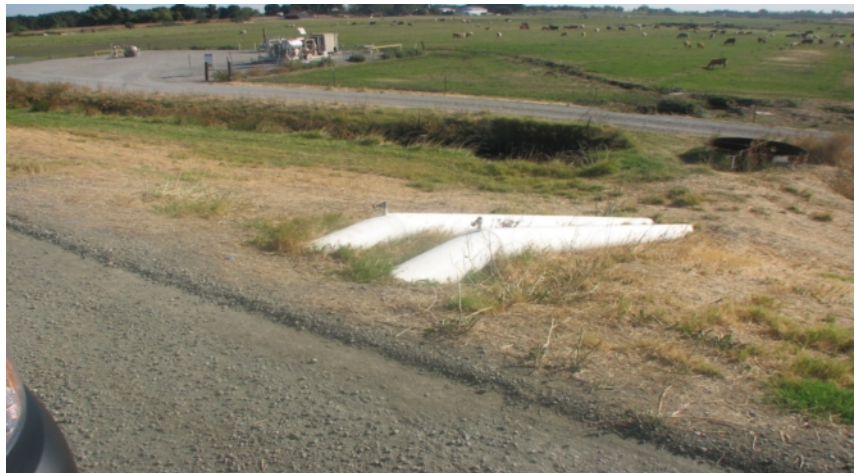
Levee Mile Report Line	2
Start Levee Mile	0.11
End Levee Mile	0.11
Location	
Category	Interior Drainage & Piping Systems
Item	Metal Pipes
Looking at above ground acceptable irrigation pipes on landside slope.

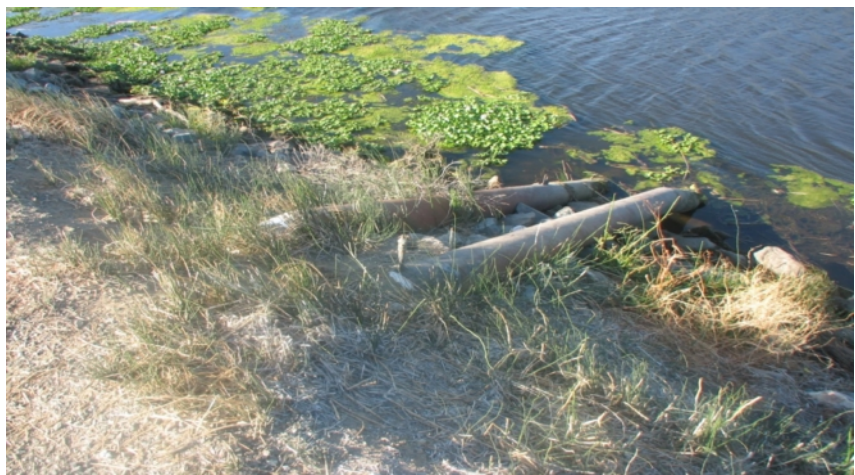
Levee Mile Report Line	2
Start Levee Mile	0.11
End Levee Mile	0.11
Location	
Category	Interior Drainage & Piping Systems
Item	Metal Pipes
Looking at above ground acceptable irrigation pipes on waterside slope.
